Manhole Inspection Summary

Manhole # S11EE1003MH

Location Address: **4209 TOWANDA AVE**

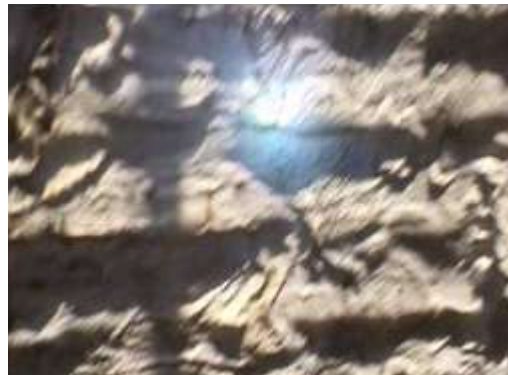
Defect 1

Steps Count: **4** Missing: **2** ☒ **Corroded**

MISSING RUNG

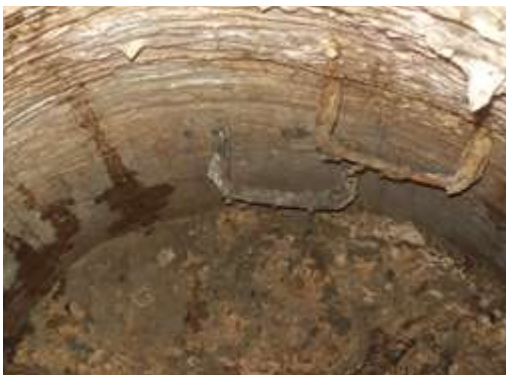
Defect 2

Surcharge ☒ **Evidence Of Surcharge** Depth: **4** (ft.) ☐ Active Surcharge Present

SURCHARGE EVIDENCE

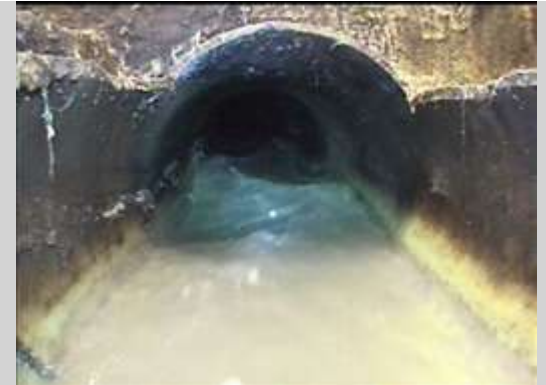
12 O'Clock Outflow

15 in. Circular Gravity Sewer
Pipe Out @ 12 O'Clock

Pipe Height: **14.4** (in.) Rod and Bar (Angled)
Pipe Material: **PVC** ☐ Pipe Lined
Invert Depth: **10.15** (ft.) Flow Characteristics: **Fast**
Deposits: ☒ None ☐ Mud ☐ Sludge ☐ Debris ☐ Grease
Silt Depth: (in.) Deposits Extent:
Infiltration: **None** Pipe Seal Cond: **Sound**

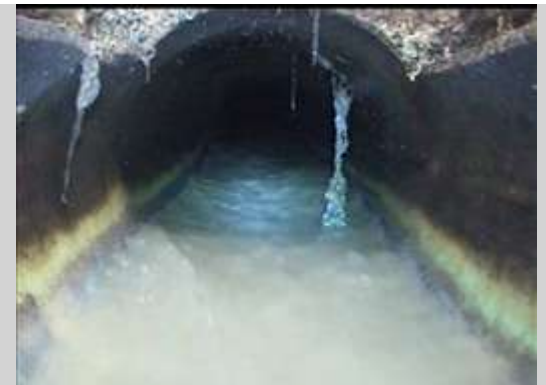
6 O'Clock Inflow

15 in. Circular Gravity Sewer
Pipe In @ 6 O'Clock

Pipe Height: **15.6** (in.) Rod and Bar (Angled)
Pipe Material: **PVC** ☐ Pipe Lined
Invert Depth: **10.20** (ft.) Flow Characteristics: **Fast**
Deposits: ☒ None ☐ Mud ☐ Sludge ☐ Debris ☐ Grease
Silt Depth: (in.) Deposits Extent:
Infiltration: **None** Pipe Seal Cond: **Sound**
